www.smarterinventories.com

## Check-out Report

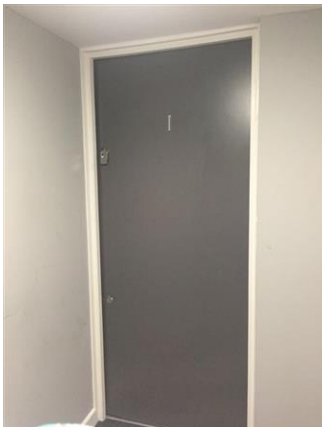
No change to previous report

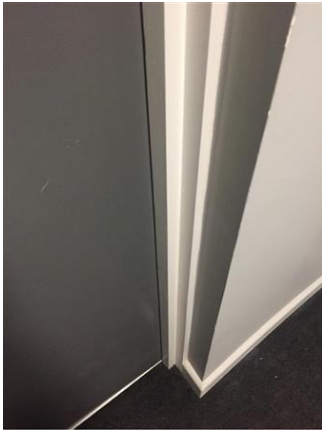
White painted door frame  
Cracked to joinery

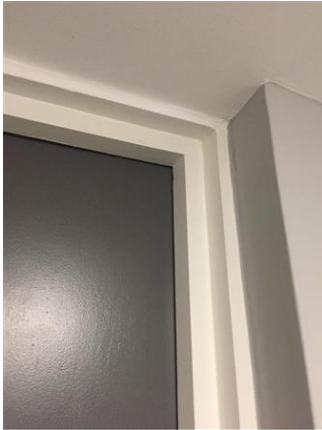
Additional photo of the cracks

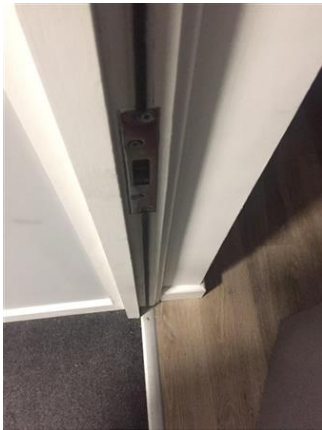
Silver threshold  
Good condition

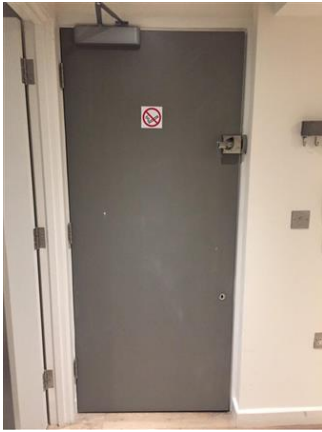
Internal view to match  
Closing arm to the top, sticker (no smoking)

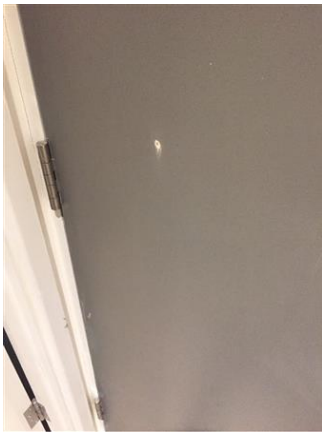
Good condition overall

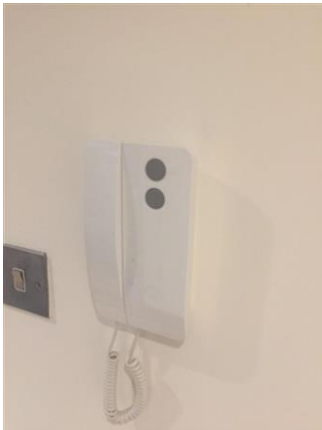
**Checkout update:**

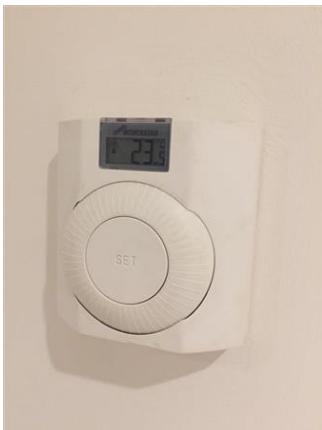
No change to previous report

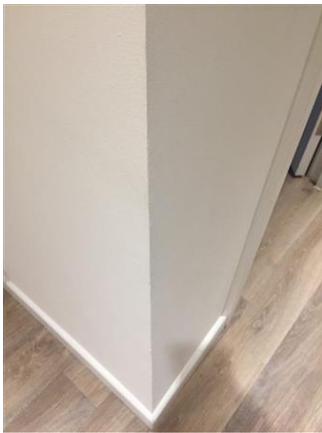
Chips / crack to the edge

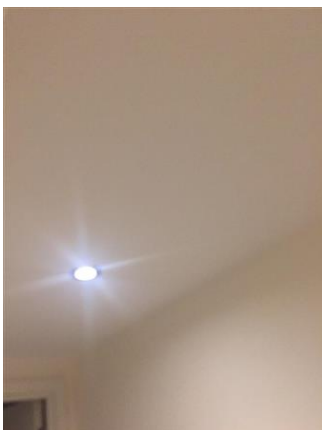
White painted ceiling  
Good condition

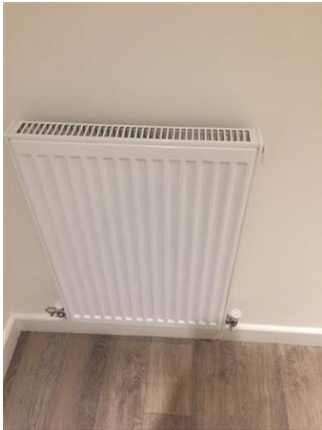
**Checkout update:**

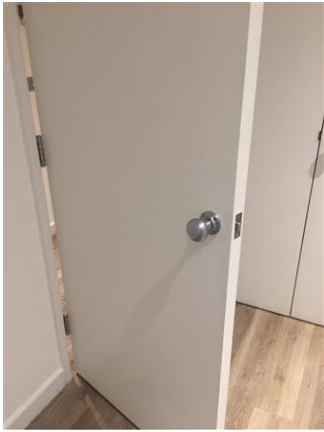
Internal view to match

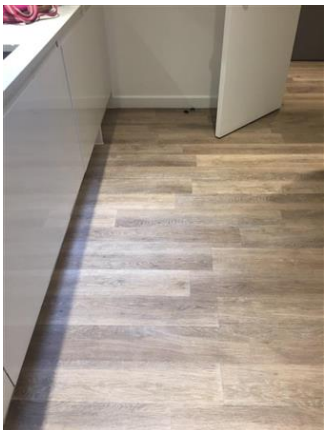
Additional photo of the floor

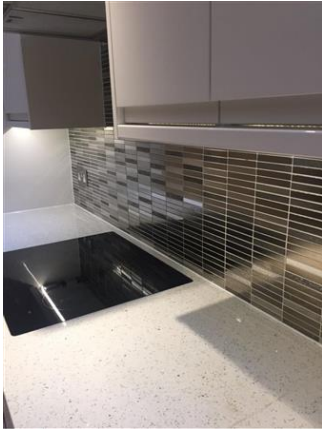
**Checkout update:**

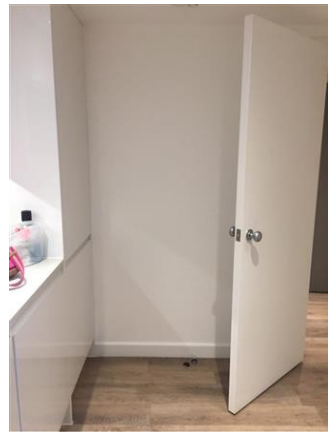
White painted walls  
White painted skirting

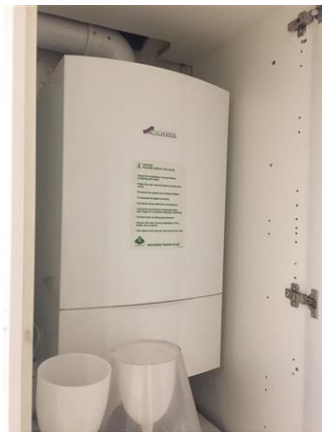
Worcester white boiler

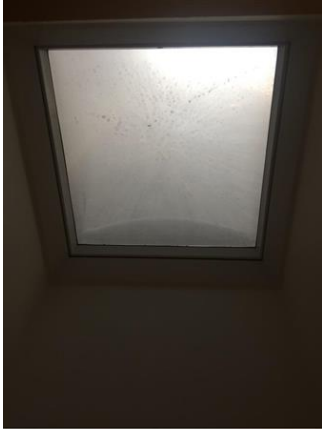
Paper to one edge (between opening and frame)  
Noted

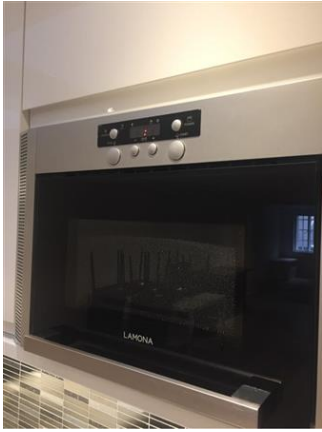
**Checkout update:**

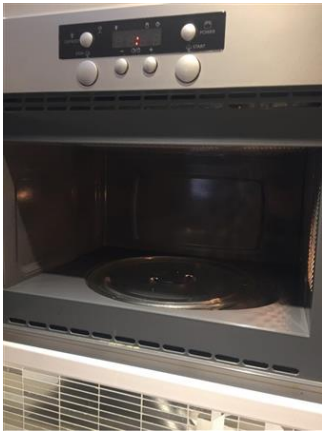
No change to previous report

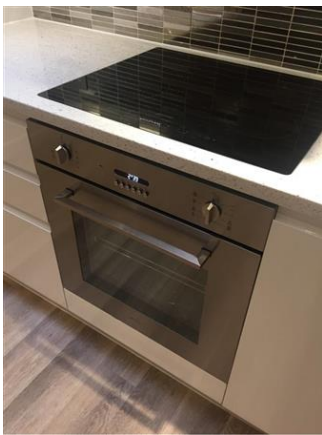
No change to previous report

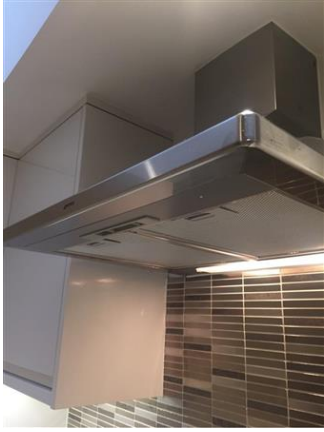
Smeg, stained steel exterior hood

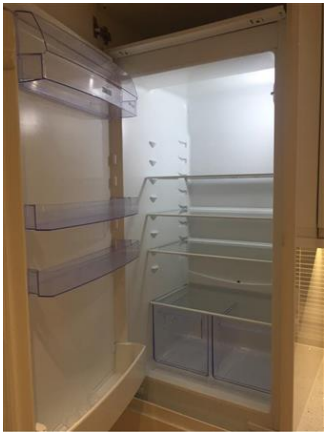
Zanussi integrated refrigerator freezer  
4x door shelves, 2x salad boxes, 5x glass shelves

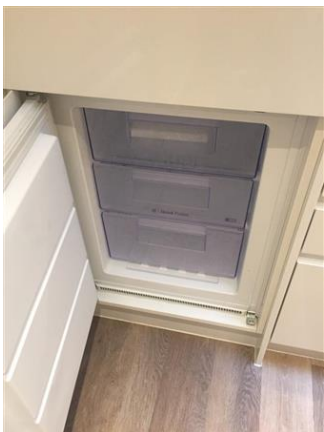
3x drawers to the freezer

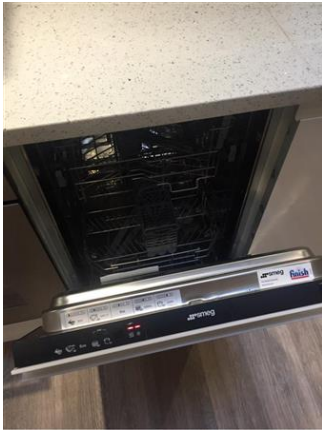
Smeg, integrated dishwasher

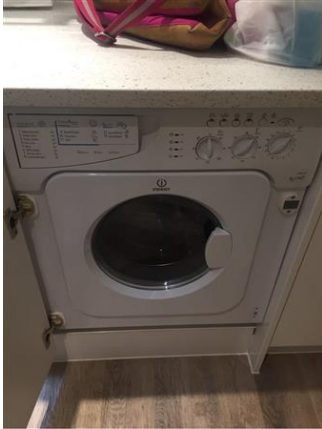
Indesit washer dryer

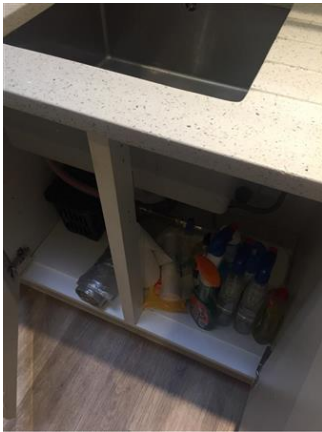
Internal view of the sink cabinet

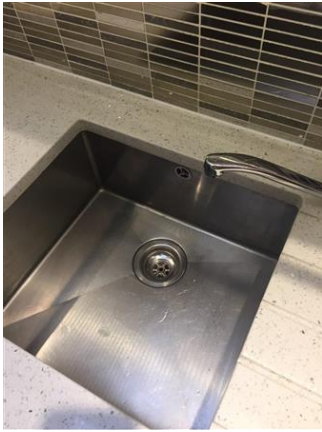
Stained steel, single bowl sink and chrome mixer tap  
Water marks,  
good condition overall

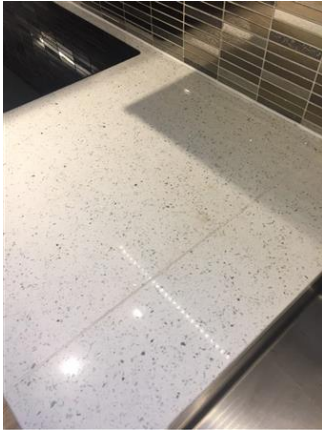
Light yellow marks near the sink

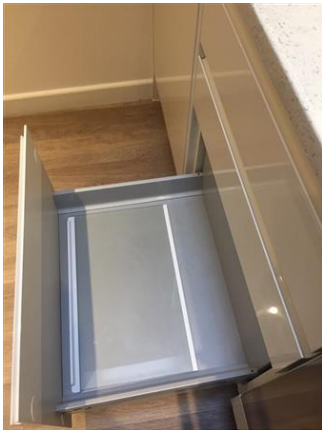
Broken part inside bottom drawer

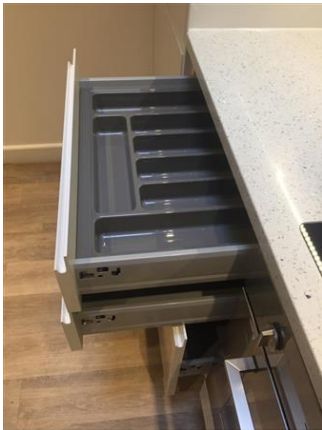
No change to previous report

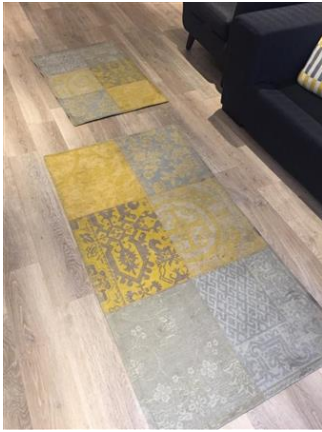
Yellow and grey medium size rug

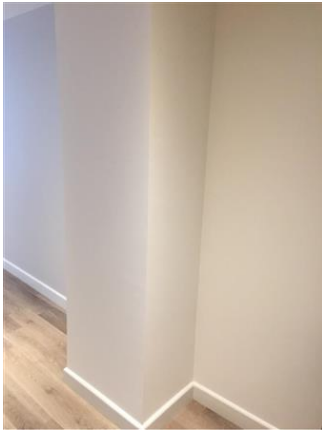
Various marks in few places

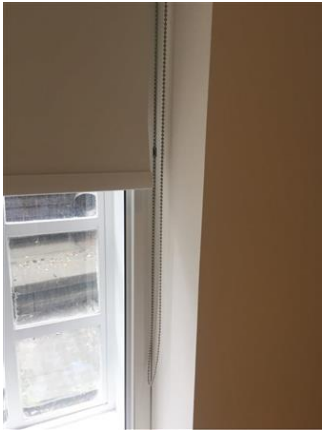
No change to previous report

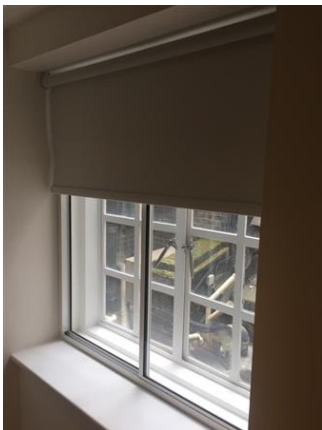
White roller blind to rhs window

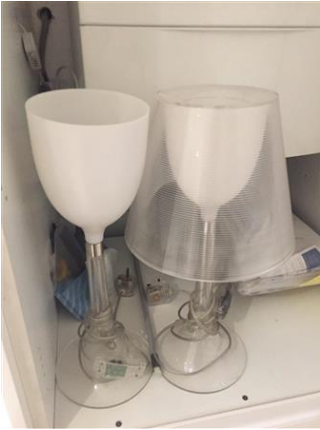
**Checkout update:**

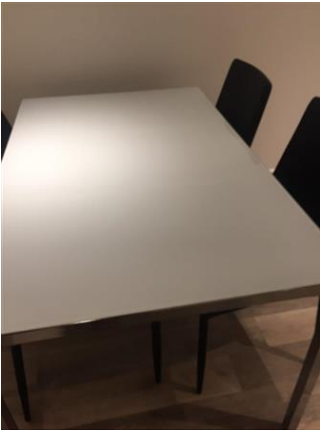
**Checkout update:**

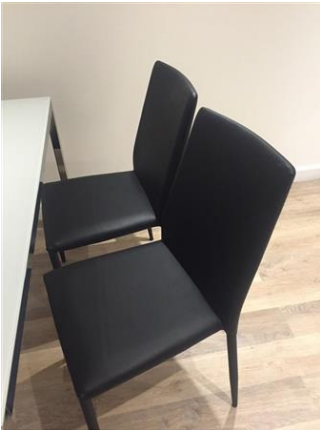
4x black leather effect chairs  
All in good condition

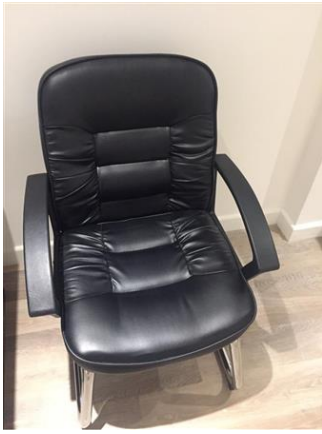
Black leather effect and chrome frame chair No change to previous report

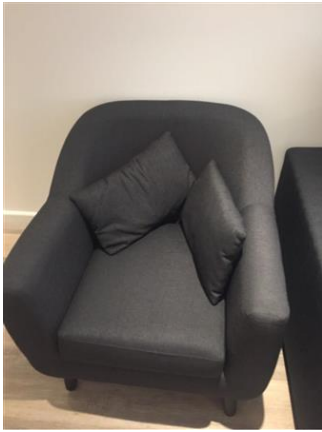
Grey fabric armchair

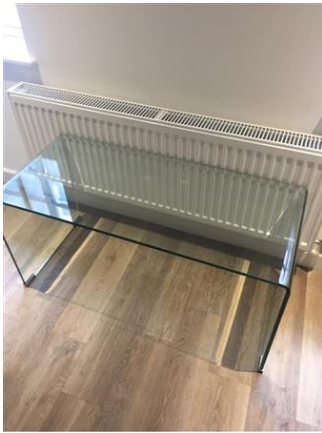
Clear glass coffee table

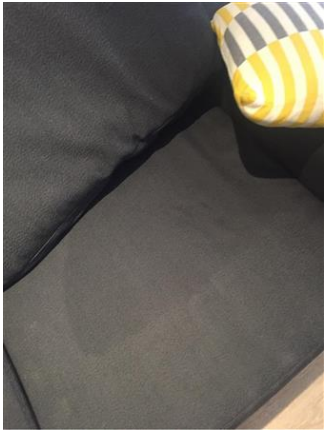
Additional image of the sofa seat

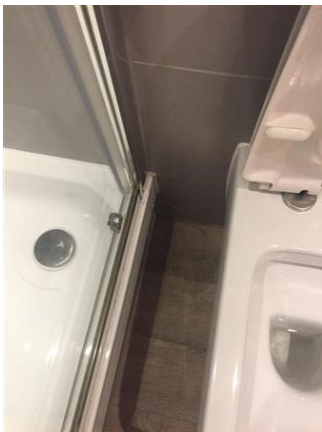
Rusty mark lhs of the Wc

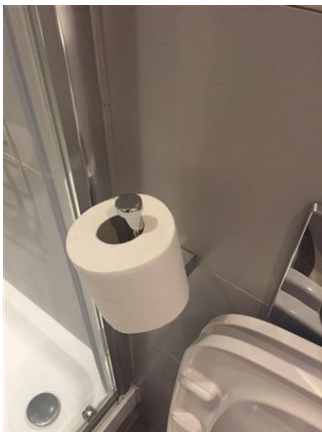
Chrome toilet roll holder

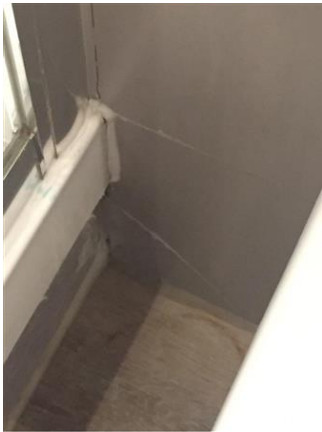
One tile cracked lhs of WC

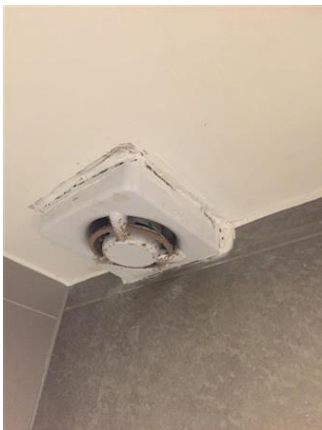
Settlement cracks lhs (above shower area)

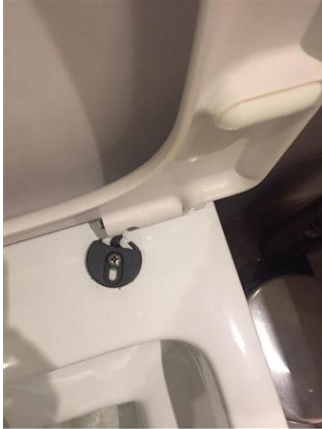
Needs cleaning inside

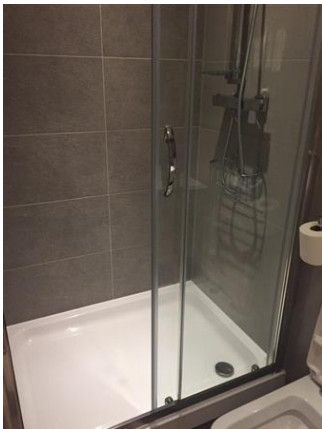
Built in shower cubicle with clear glass sliding door

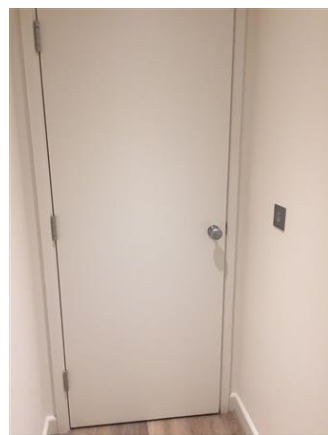
Internal view to match

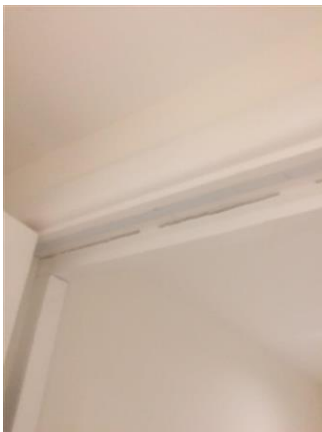
Additional image  
Cracked frame to joinery

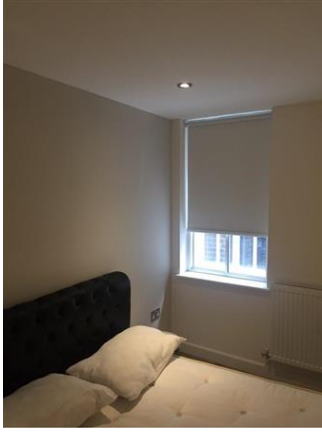
Scuffs and finger prints

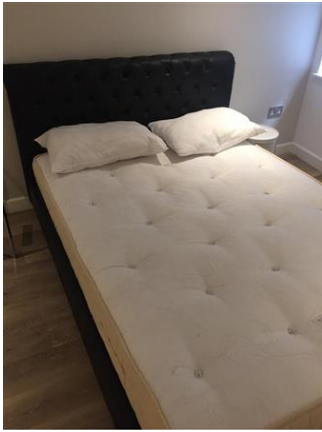
Black leather effect, double bed frame

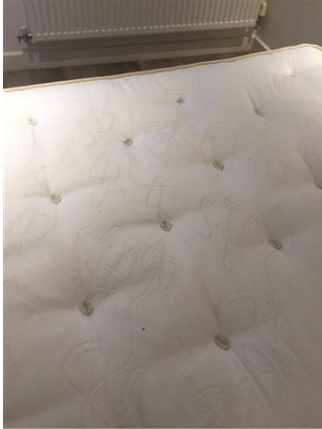
White double mattress

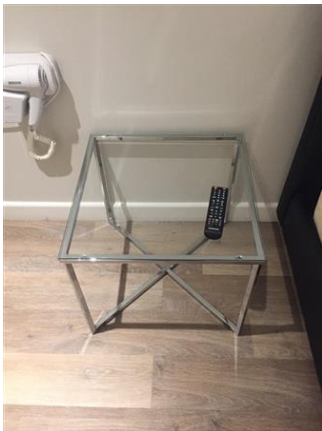
Chrome and clear glass bedside table

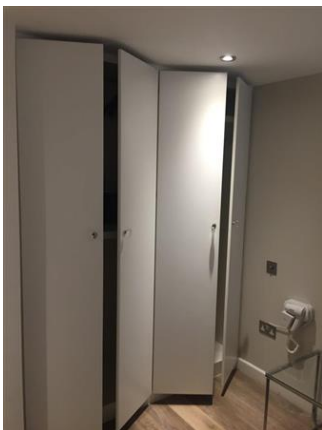
2x double door, built in wardrobe, white painted door, knob handles

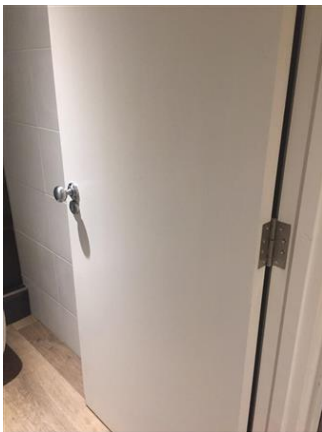
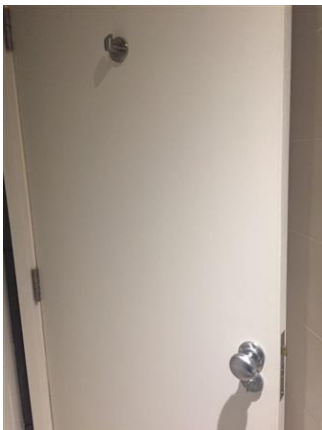
Internal view to match  
Single hook and twist lock (working order)

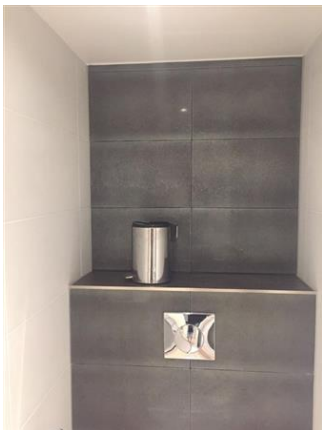
**Checkout update:**

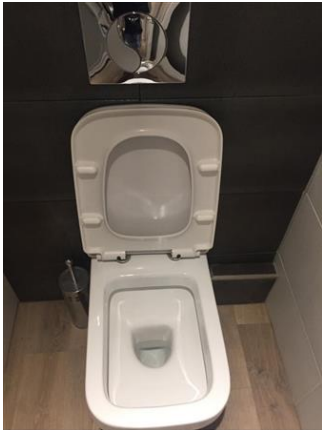
Chrome push button  
Not working properly

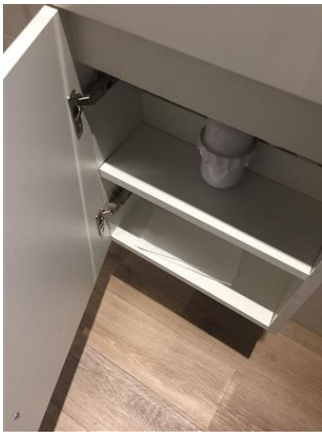
Single door cabinet below basin

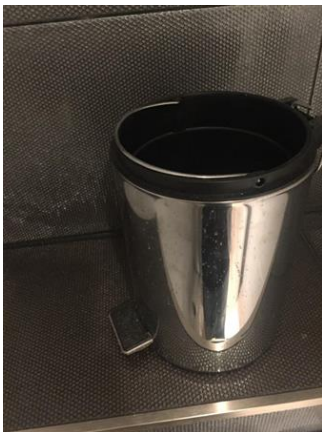
**Previous comment:**
